2017 Hurricane Harvey Deployment  
Arkema Facility Response  
8/31/2017 7:16:37 PM

***2017 ASPECT Preliminary Report  
Arkema Plant Response  
Crosby, TX***

***August 31, 2017  
0600 hrs to 1900 hrs***

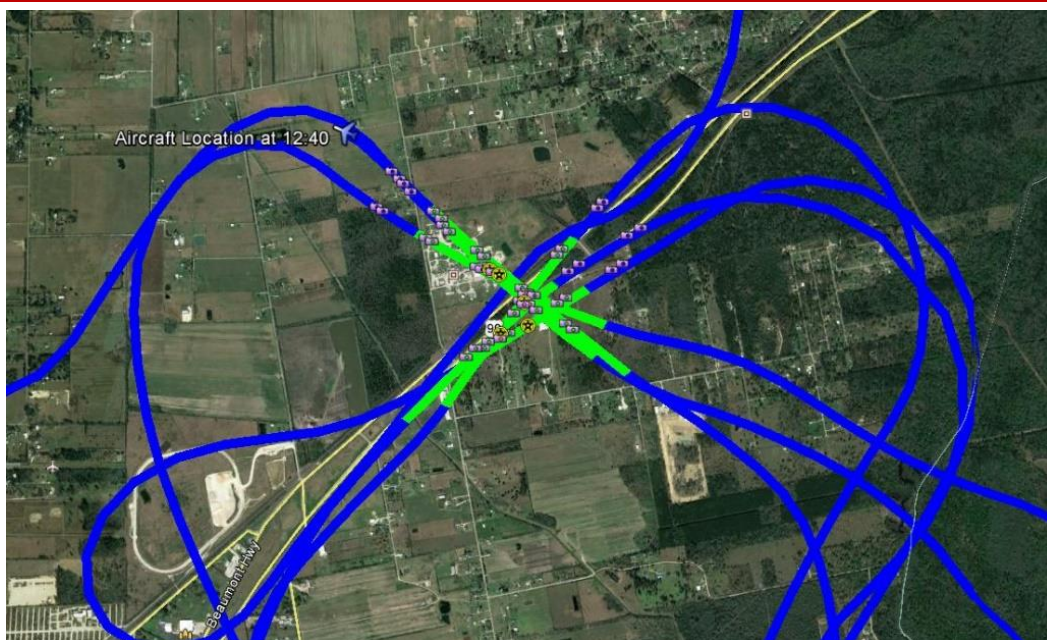
*Figure 7: Flight path over the facility at 0731 hrs CST (1231 hrs UTC) showing several passes where aerial imagery and IR sensors were active.*

0810 hrs: The aircraft crew reported that it appears the fires has burned out.
